Dam ID: H1 00114  
Piwai Reservoir

Inspection No: \_\_\_\_\_  
Date: 03/20/2006

STATE OF HAWAII - DLNR  
VISUAL DAM SAFETY INSPECTION SHEET

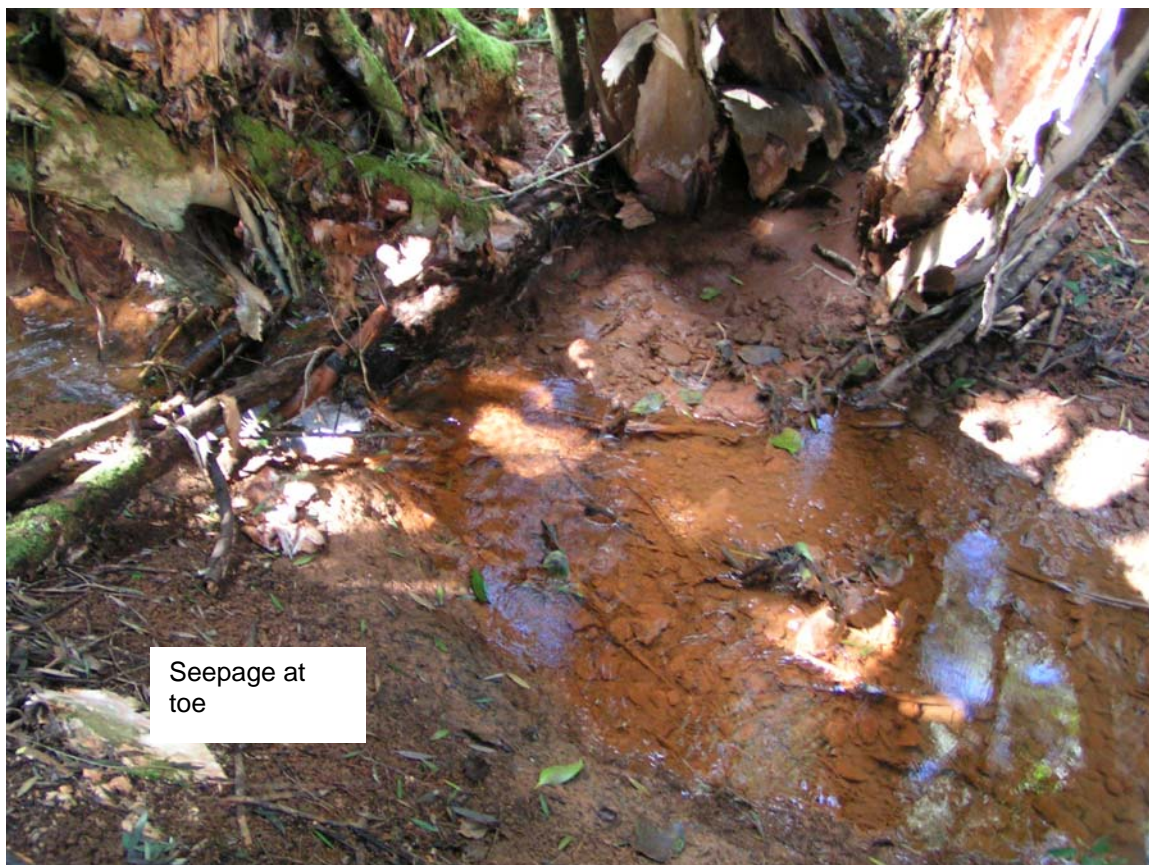
Description: 50 GPM – flowing from toe but due to ponding and soft ground and vegetation couldn't follow to slope toe

- X h. Seepage/Ponding water was observed. Monitor and conduct further investigation to locate the source of water and extent of any possible hazardous or developing condition.

Seepage at  
toe

- If seepage is observed, a V-notch weir, Parshall flume, etc., should be installed along or near the downstream toe of the dam to collect & monitor/measure the rate or volume of seepage with respect to changes (i.e. increase & decrease) in reservoir (pool) elevation.

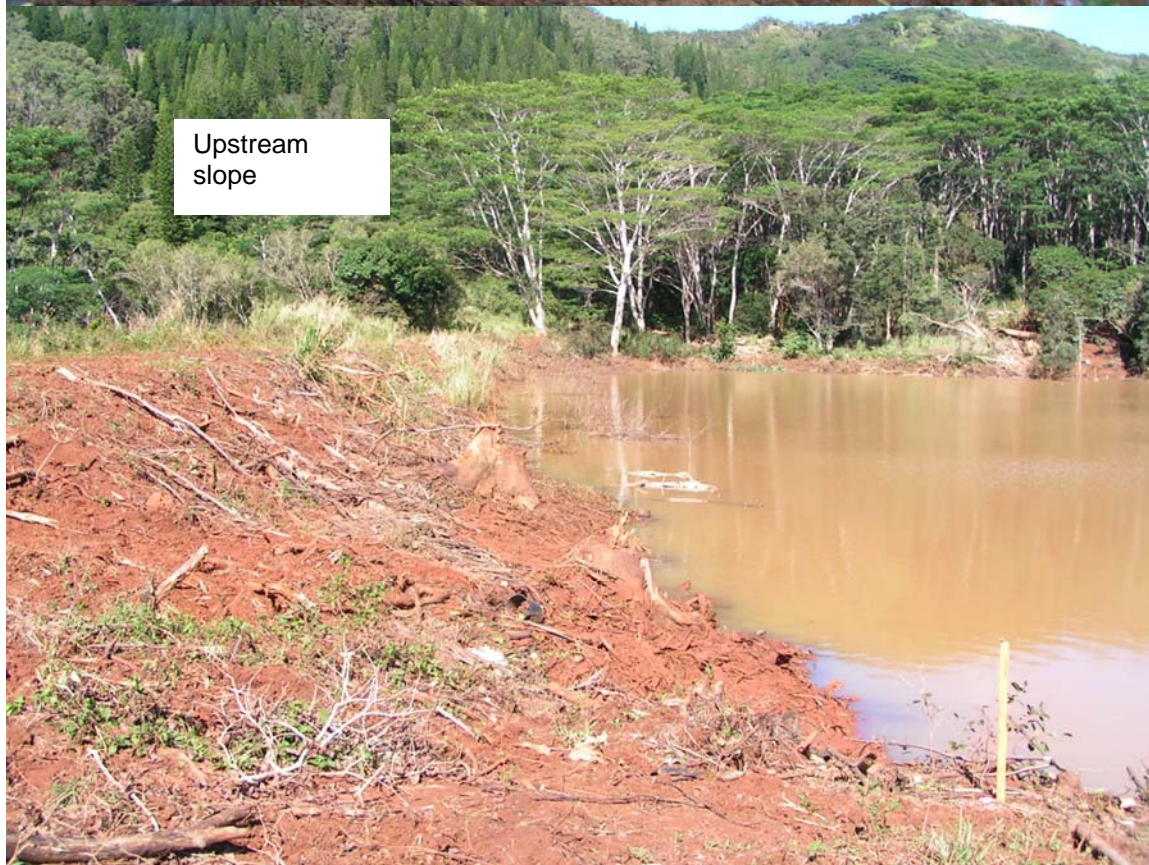
- ☒ k. None – except slope is very steep.

Upstream  
slope
